After testing the Advanced 918 Light Table Prototype and reviewing the specifications, we arrived at the following list of items to be modified or repaired.

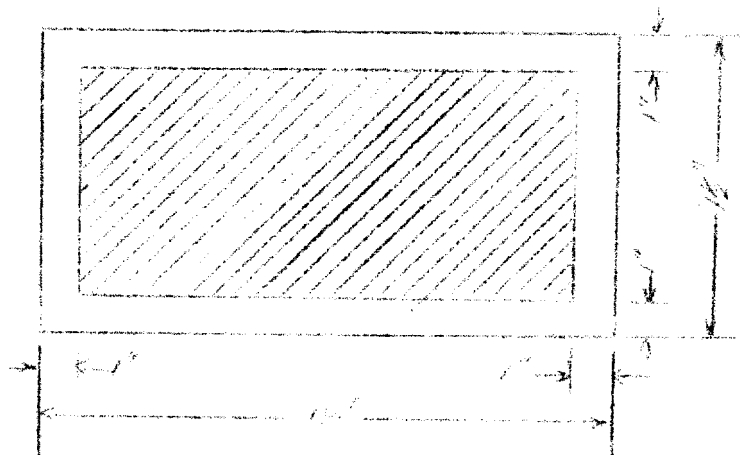
g. The illumination system must provide a maximum illumination of at least 2,000 ft. lamberts within a 2" radius of the geometric center of the illuminated area. The maximum linear brightness gradient must not exceed 15% between any two measurements taken within the shaded area shown on the diagram below, nor 25% anywhere within the illuminated area.
